Acoustic Monitoring on the Fred Hartman Bridge

Alan Kowalik, P.E.¹

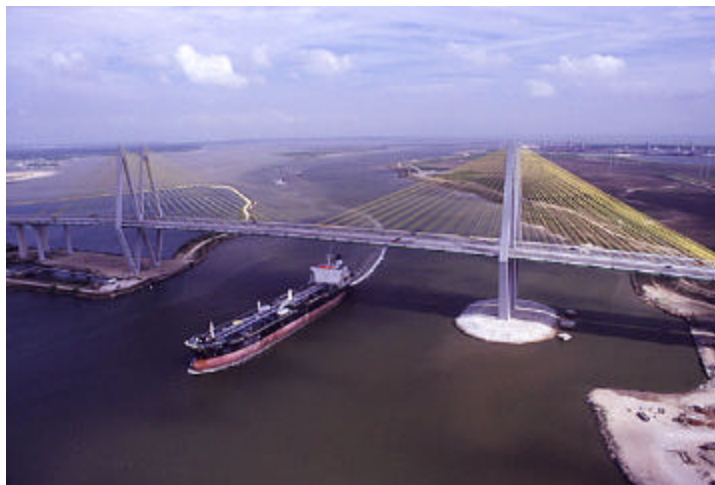
Figure 1. The Fred Hartman Bridge

In 1995 a new bridge was opened to traffic crossing the Houston Ship Channel in Texas. (See Figure 1.) The Fred Hartman Bridge crosses the Houston Ship Channel and is between Baytown and LaPorte on State Highway 146. Its superstructure includes twin 78-foot wide composite concrete decks, each supported on steel plate girders. One hundred and ninety-two stay cables fan out from four diamond-shaped concrete towers to support the superstructure on the outsides of each deck.

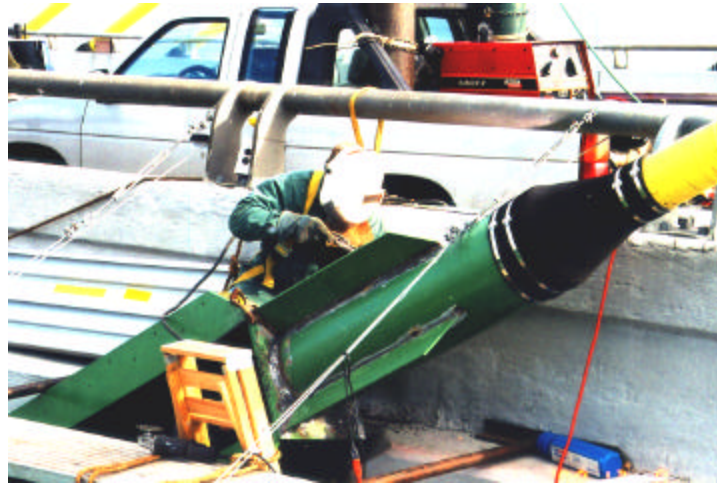
Figure 2. Fred Hartman Bridge Stay Cable Anchor

of Transportation (TxDOT) inspection personnel discovered cracking in welds of steel transition pipes connecting the stay cables to the superstructure, and they attributed the cracking to cyclic loading from the oscillations. TxDOT immediately initiated investigation into the serviceability and long-term durability of the stay cable system. The investigation focused on fatigue of the steel strands in the stay cable, but cracking of the protective grout in the stay cable was also a concern. (See Figure 2.)

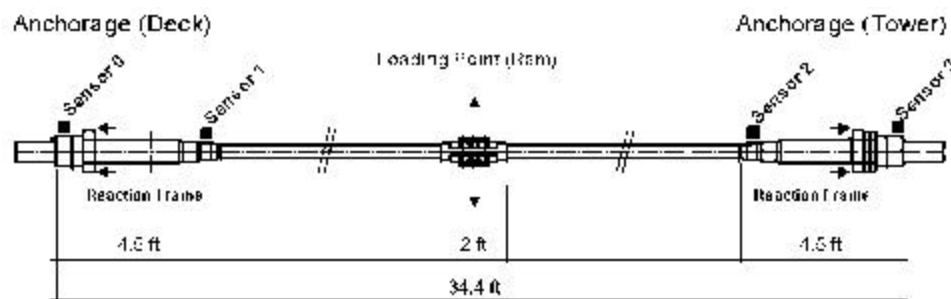
Figure 3. Test Setup with Acoustic Sensors

Researchers installed the stressed and grouted cable into the loading and reaction frames and positioned the loading ram. (See Figure 3.) The loading ram was set to cycle the cable at an amplitude of ± 1.6 inches at a frequency of 0.7 to 0.9 Hz. Strain gauges were placed on the cable at the anchorage points, tension rings, and along the free length. Pure Technologies Ltd. placed acoustic monitoring sensors on the cable at four locations to determine if wire break events could be detected and located.

During 2,800,000 cycles, the acoustic monitoring system registered 14 wire break events at the anchor representing the upper end of the stay at the tower and 11 breaks at the loading point. Pure Technologies Ltd. triangulated each point using data from the four gauges. The cable was then cut into five seven-foot segments and autopsied to verify the position and location of wire breaks. The autopsy revealed 14 breaks within a 24-inch range from the tower anchor and 11 breaks within a 24-inch range from the loading point. Thirteen out of 14 wire breaks at the tower anchorage were found inside the range reported by Pure Technologies Ltd. The one remaining wire break was found 7 inches outside the reported range. Three out of 11 wire breaks under the loading point were found inside the reported range. The eight remaining wire breaks were all found within 8 inches outside of the reported range, towards the deck side.

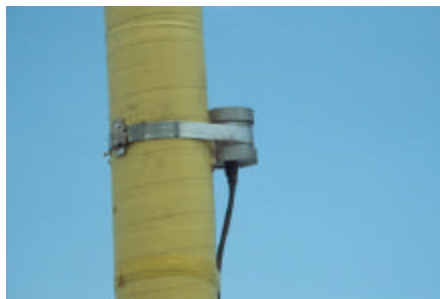
Figure 4. Acoustic Sensor Installed on Stay Cable

Full implementation of acoustic monitoring of the Fred Hartman Bridge began in April 2002. TxDOT contracted with Pure Technologies Ltd. to install the SoundPrint® system to detect and locate failures in the stay cables. Three acoustic sensors were attached to each stay cable: one at the deck anchorage, one above the anchorage near deck level, and one at the tower anchorage. (See Figure 4.) A total of 576 sensors were installed to monitor all 192 stay cables. The sensors were attached to the anchors and cable stays with epoxy and strapping. Twisted pair cable was run from each sensor through conduit, to protect it from the elements, vandalism and other construction and maintenance hazards, to the data acquisition unit located in one of the pylon legs. (See Figure 5.) Telephone service and electrical power was also provided to the data acquisition unit.

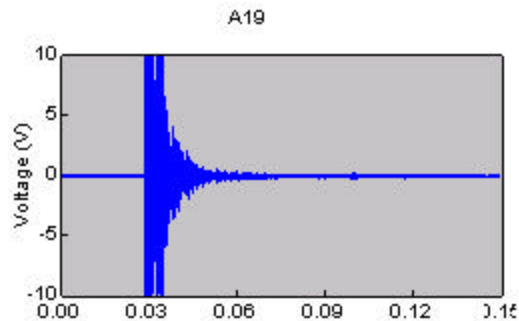
Figure 6. Acoustic Sound Print of a Wire Break

Bridge Division Field Operation Section Director, etc.) are notified by email, phone, or pager identifying when the event occurred and the location of the event. On June 25, 2002, Pure Technologies notified TxDOT personnel of a possible wire break on stay cable No. 6 on the South Tower of Line “D”(Stay D-6). (See Figures 6 and 7.) Although construction was underway on that day, TxDOT personnel verified that because of a rainstorm, no construction work was occurring at the time of the event. Additionally, personnel had noticed that during the rainstorm many of the stay cables were oscillating from the wind and rain.

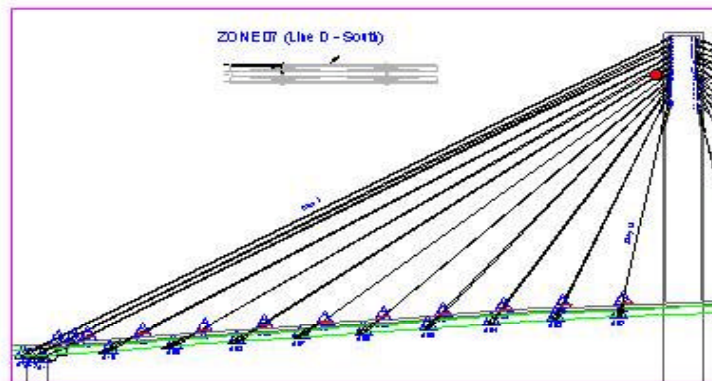
Figure 7. Wire Break Location

TxDOT personnel inspected the upper anchorage of Stay D-6 but found no evidence of any structural problem associated with this wire break. “Pluck” testing of this stay to evaluate the stay force has also been performed. At this time, there is no indication of loss of force in this stay. The location of the event has been noted, and a more thorough investigation may be performed to determine the condition of the stay cable.
